SUBJECT : SAFETY OF HILL SLOPES AROUND NAINI TAL.

Geological report on the stability of the Hillside at Naini-Tal by Mr. J.B. Auden.

REPORT
ON THE
SAFETY OF CERTAIN AREAS
IN
NAINI TAL
1939

BY
A. L. COULSON, D.Sc., D.I.C., F.G.S., F.N.I.,
Superintending Geologist, Geological Survey of India

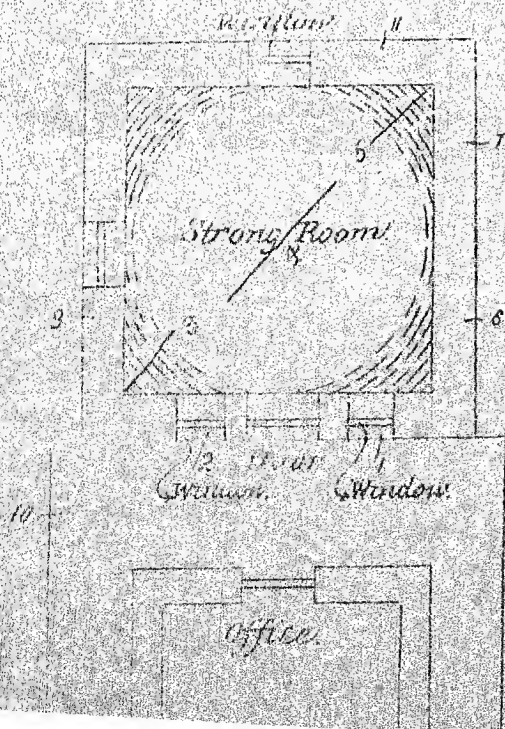
Cracks in building.—The cracks noticed last year in the treasury strong room have not increased in width to any appreciable amount, but the diagonal crack which was only visible last year in the floor (No. 4 on plan) and in the south-west corner (No. 5 on plan) is now visible, also at 2, 3 and 9 in the north-east corner. The cracks are in no way serious. Tell-tales have been placed in eleven places and periodical measurements are made of them. The following sketch and table show the position of the tell-tales and the measurements recorded :—

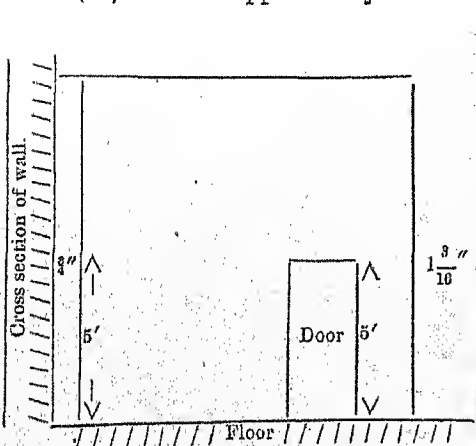
- (9) The floor of the corridor from end to end has cracked considerably and has now been thoroughly repaired.
- (10) In the staff quarters there are considerable cracks in the east wall of the north room over each of the doors, and minor cracks in other parts shown on plan.

- (11) Besides these, there are numerous minor cracks over almost all openings in the lower storey of the building. These are detailed on the plan.
- (12) In the upper storey there is a corresponding crack to that in the lower in the corridor arches, which was filled and papered over in 1881, and which has since shown no sign of increase, as the paper on the arches is unbroken. There is also a separation between the upright woodwork at the end of the corridor and the wall, as shown in margin, but this cannot be depended on as evidence of separation in the building to the extent indicated, as much may be due to shrinkage of the wood.

5. (ii) *Probable causes of the present defective state of the building.*—The Committee is unanimously of opinion that the cracks, which are all longitudinal, were consequent upon the general disturbance of the hill during the cyclone of September 1880.

6. Mr. Ashhurst and Mr. Henslowe also are of opinion that unequal consistency in the subsoil under foundations has probably tended to increase the cracks, which tendency might perhaps have been prevented had a broader and thicker beam of concrete been given under each of the walls than it is understood has been provided.
